Inspection Report Minerals Regulatory Program Report Date: November 10, 2004

Mine Name: Torrey Buff and Lucero Red

Permit number: S/055/022 (Torrey Buff) and S/055/023 (Lucero Red)
(NOI's not yet accepted; bonds not received)

Inspection Date: November 4, 2004

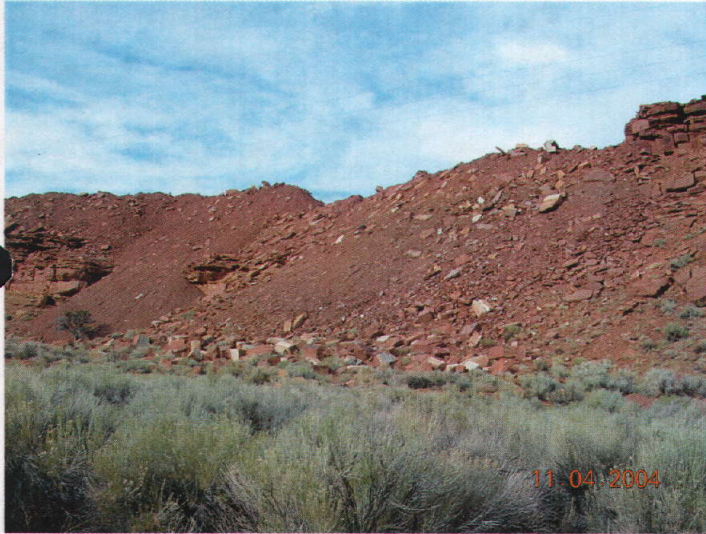
Photo 1. The outslope at the Lucero Red Quarry.

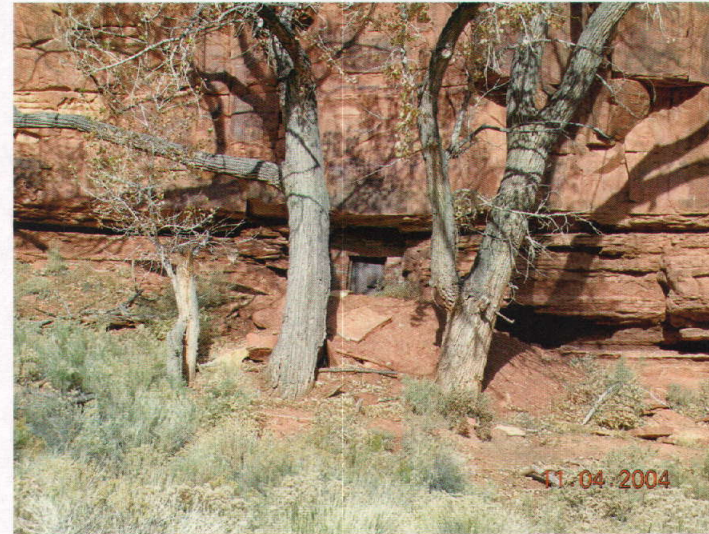
At the base of the cliff near the Lucero Red Quarry is an explosives magazine (Photo 3). I believe this may be the responsibility of Bruce Hansen.

Photo 3. Explosives magazine at the base of the cliff to the east of the Lucero Red Quarry.

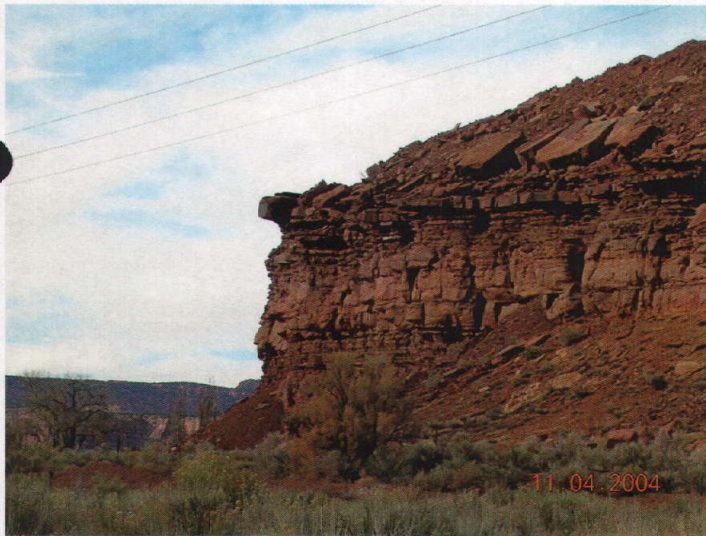
Photo 2. Another view of the Lucero Red outslope. Note the material at the base of the cliff on the left.

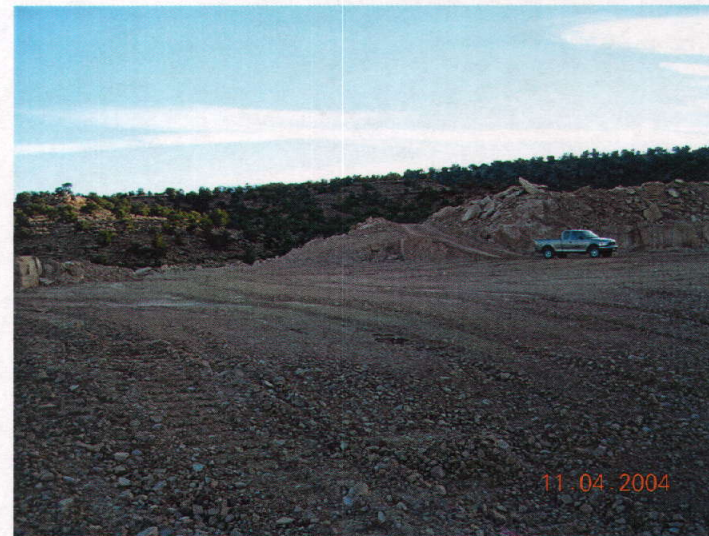
Photo 4 The top of the graded area at the Torrey Buff Quarry. The outcrops of this area are shown in Photo 9.

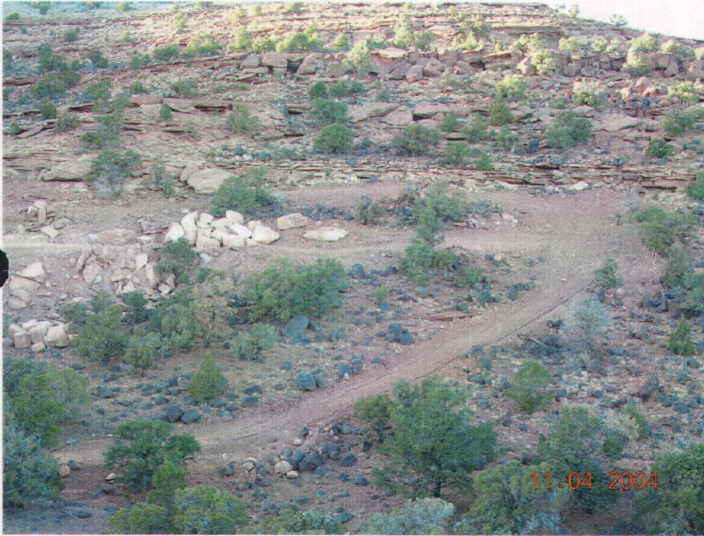
Photo 5. Area being reclaimed at the Torrey Buff Quarry.

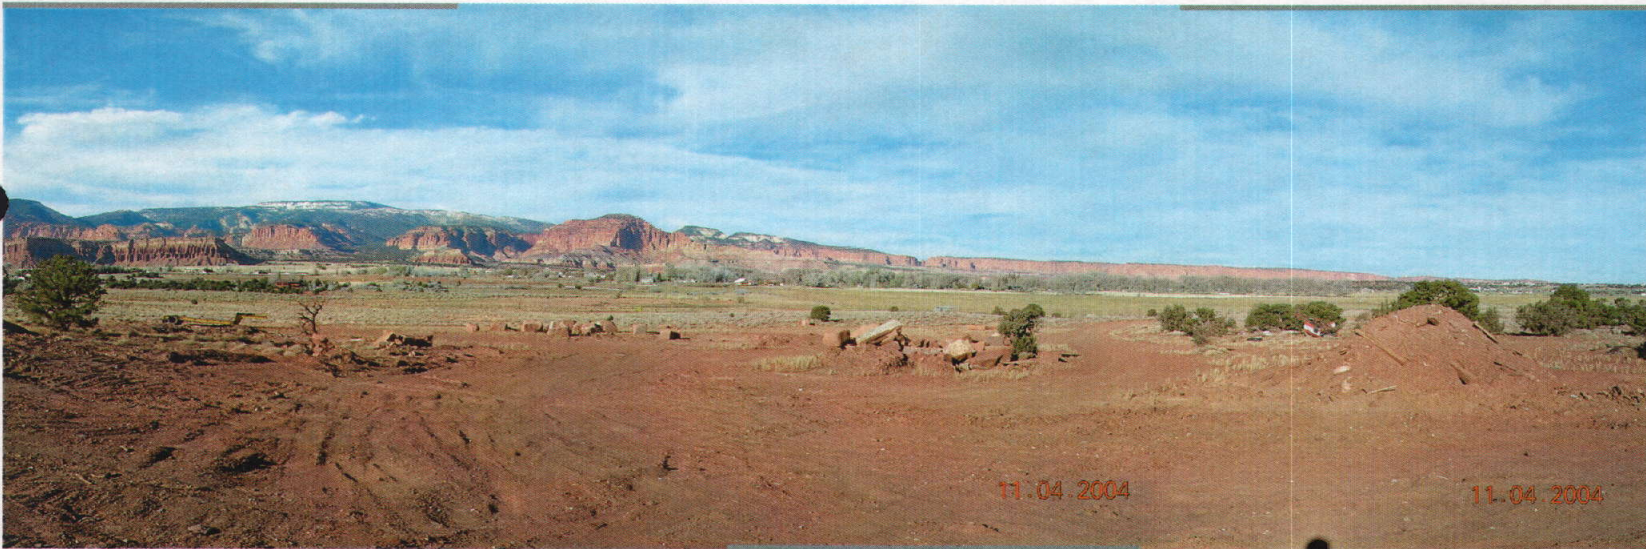
Where the stone has been hauled away, the ground is still disturbed, and it was impossible for me to tell whether these areas are going to be used for future operations. Portions of the areas where stone has been and is being stored area shown in Photos 6 and 7. The operator needs to finish taking away stone from areas that will no longer be used for loading and consolidate all operations as much as possible. I strongly suggest that the disturbed areas then be marked with T-posts to make it clear what is and what is not part of the disturbed area.

Photo 6. A portion of the stone storage area at the Lucero Red Quarry.

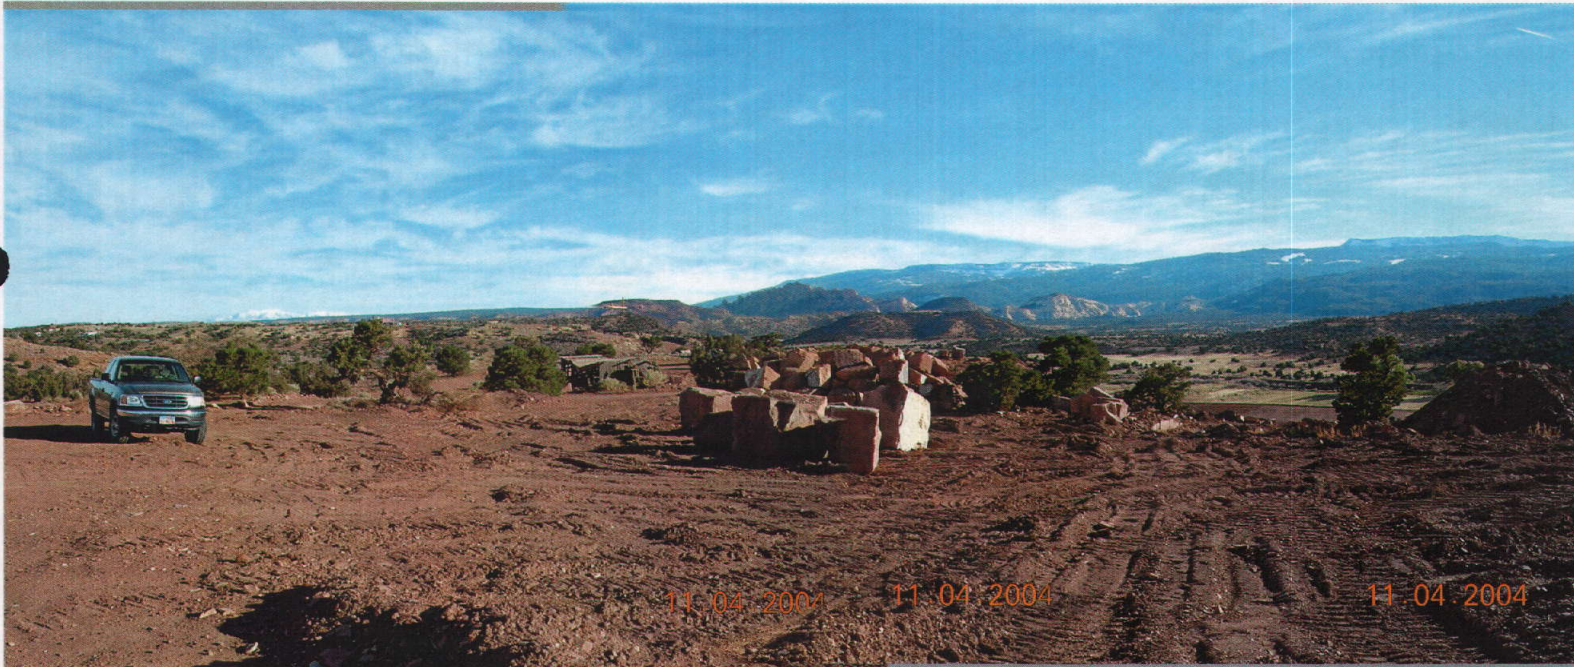
Photo 7. Another view of part of the stone storage area at the Lucero Red Quarry. Although a lot of stones have been removed, quite a few remain.

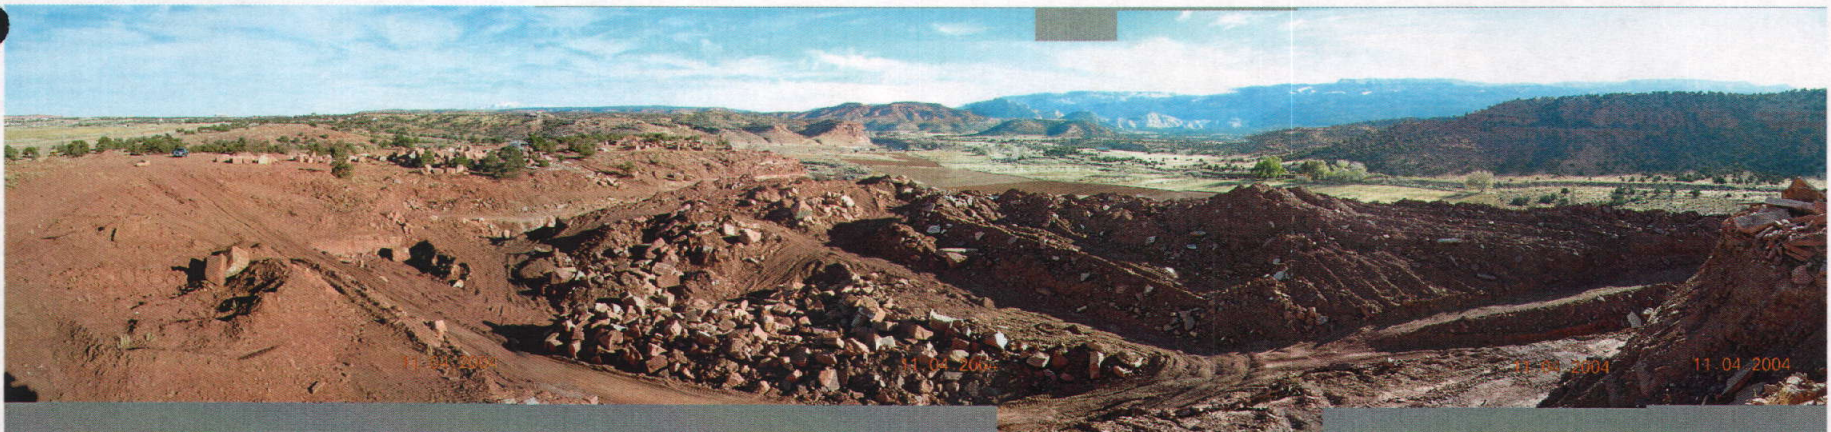
The operator has been doing reclamation work to reduce the sizes of the quarries. At the Lucero Red Quarry, a fair amount of stone has been taken away. There may have been some work to reduce the size of the pit (Photo 8), but, if so, the amount of work has been limited.

Photo 8. The pit at the Lucero Red Quarry. This is a composite of five photos and has some distortion.

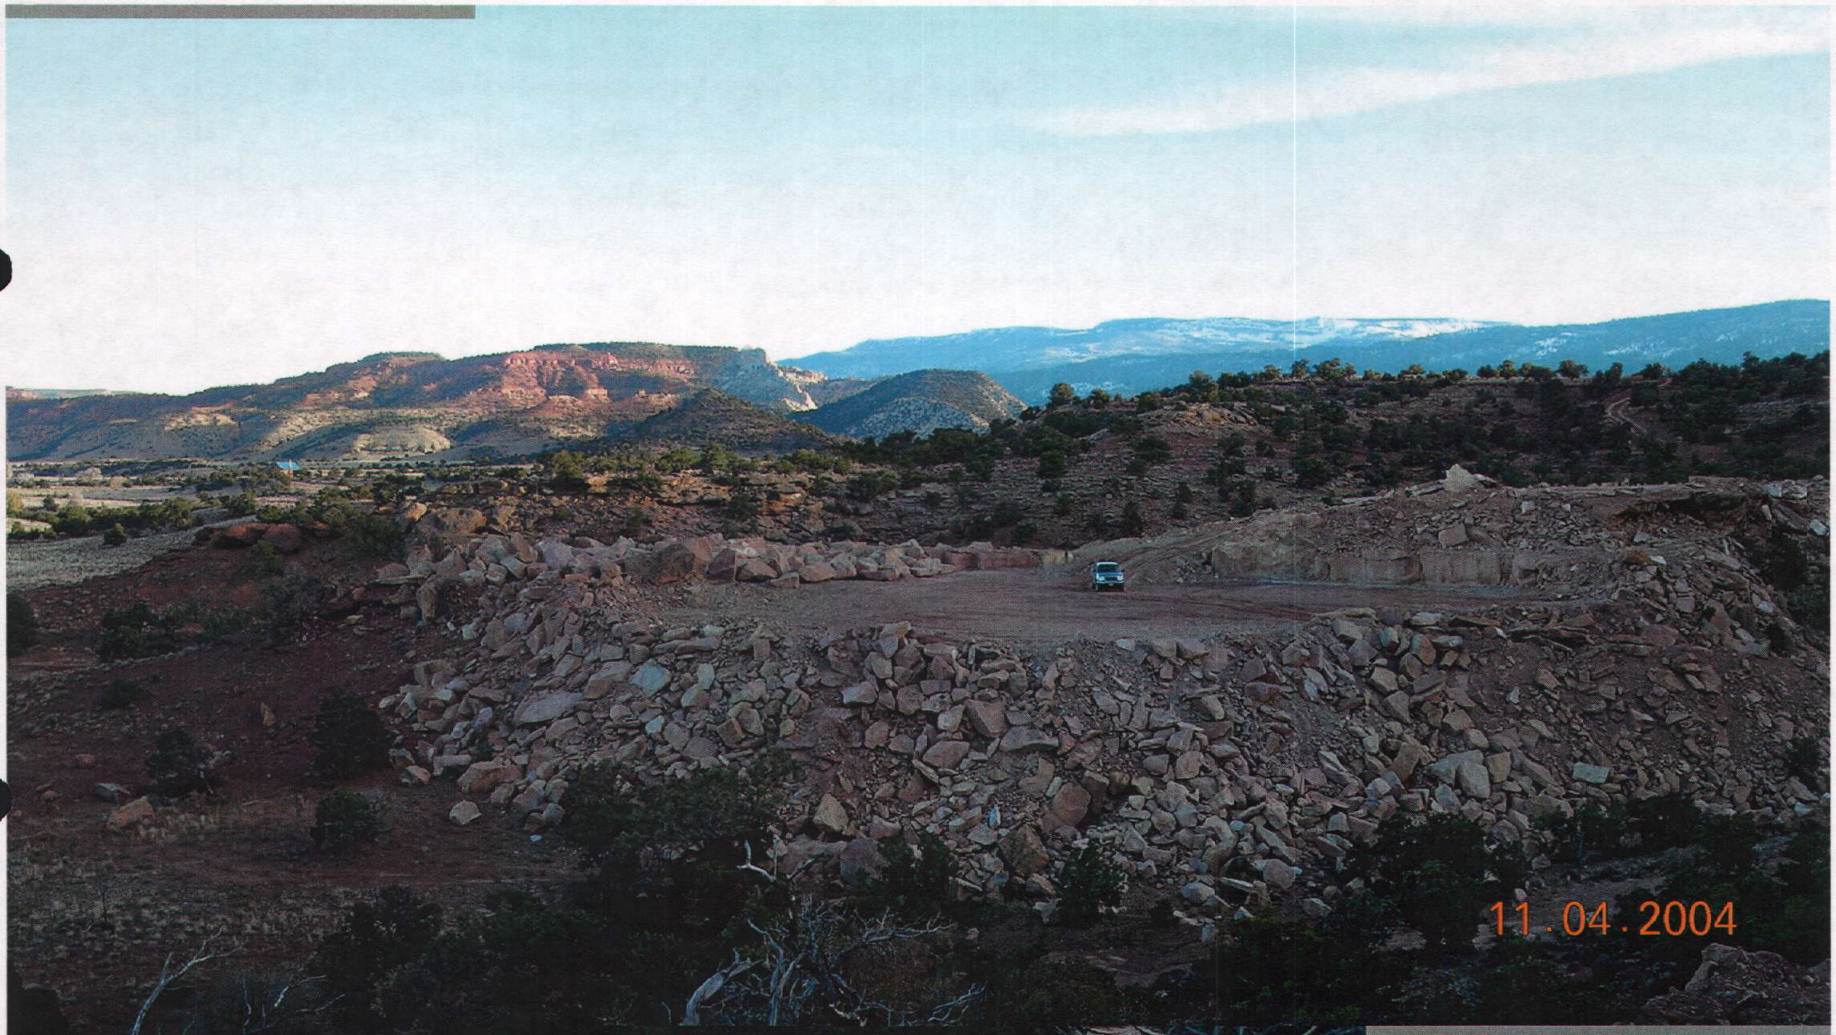
The lower part of the east portion of the buff quarry is shown in Photo 9. As can be seen, this area was graded flat and smooth with rocks pushed over the outslopes. I have mixed feelings whether this area meets grading standards. It does not blend well with surrounding areas, but once vegetation is established, it should provide more forage than some of the adjacent pinyon-juniper slopes. Since the area is so flat and devoid of rocks, it could be used by off-highway vehicles. I have asked the Bureau of Land Management to comment on this grading.

Photo 9. A portion of the regraded area at the Torrey Buff Quarry. Note how flat and smooth the top is. This area should be roughened prior to seeding. In the future, the operator should attempt to blend areas like this into the surrounding terrain and to leave some rock on the surface.

- 1) Notify the Division when grading work is being done so the Division can visit the site and make recommendations.
- 2) Try to blend the disturbed area with surrounding topography. This includes adding a little slope and leaving some rocks on the surface.
- 3) Salvage and spread soil.
- 4) Leave the surface rough.

I spoke with Mr. Pace about preparing the site for seeding. It needs to be left very rough, and seed should be planted as soon as possible after surface preparation. This should happen before December.

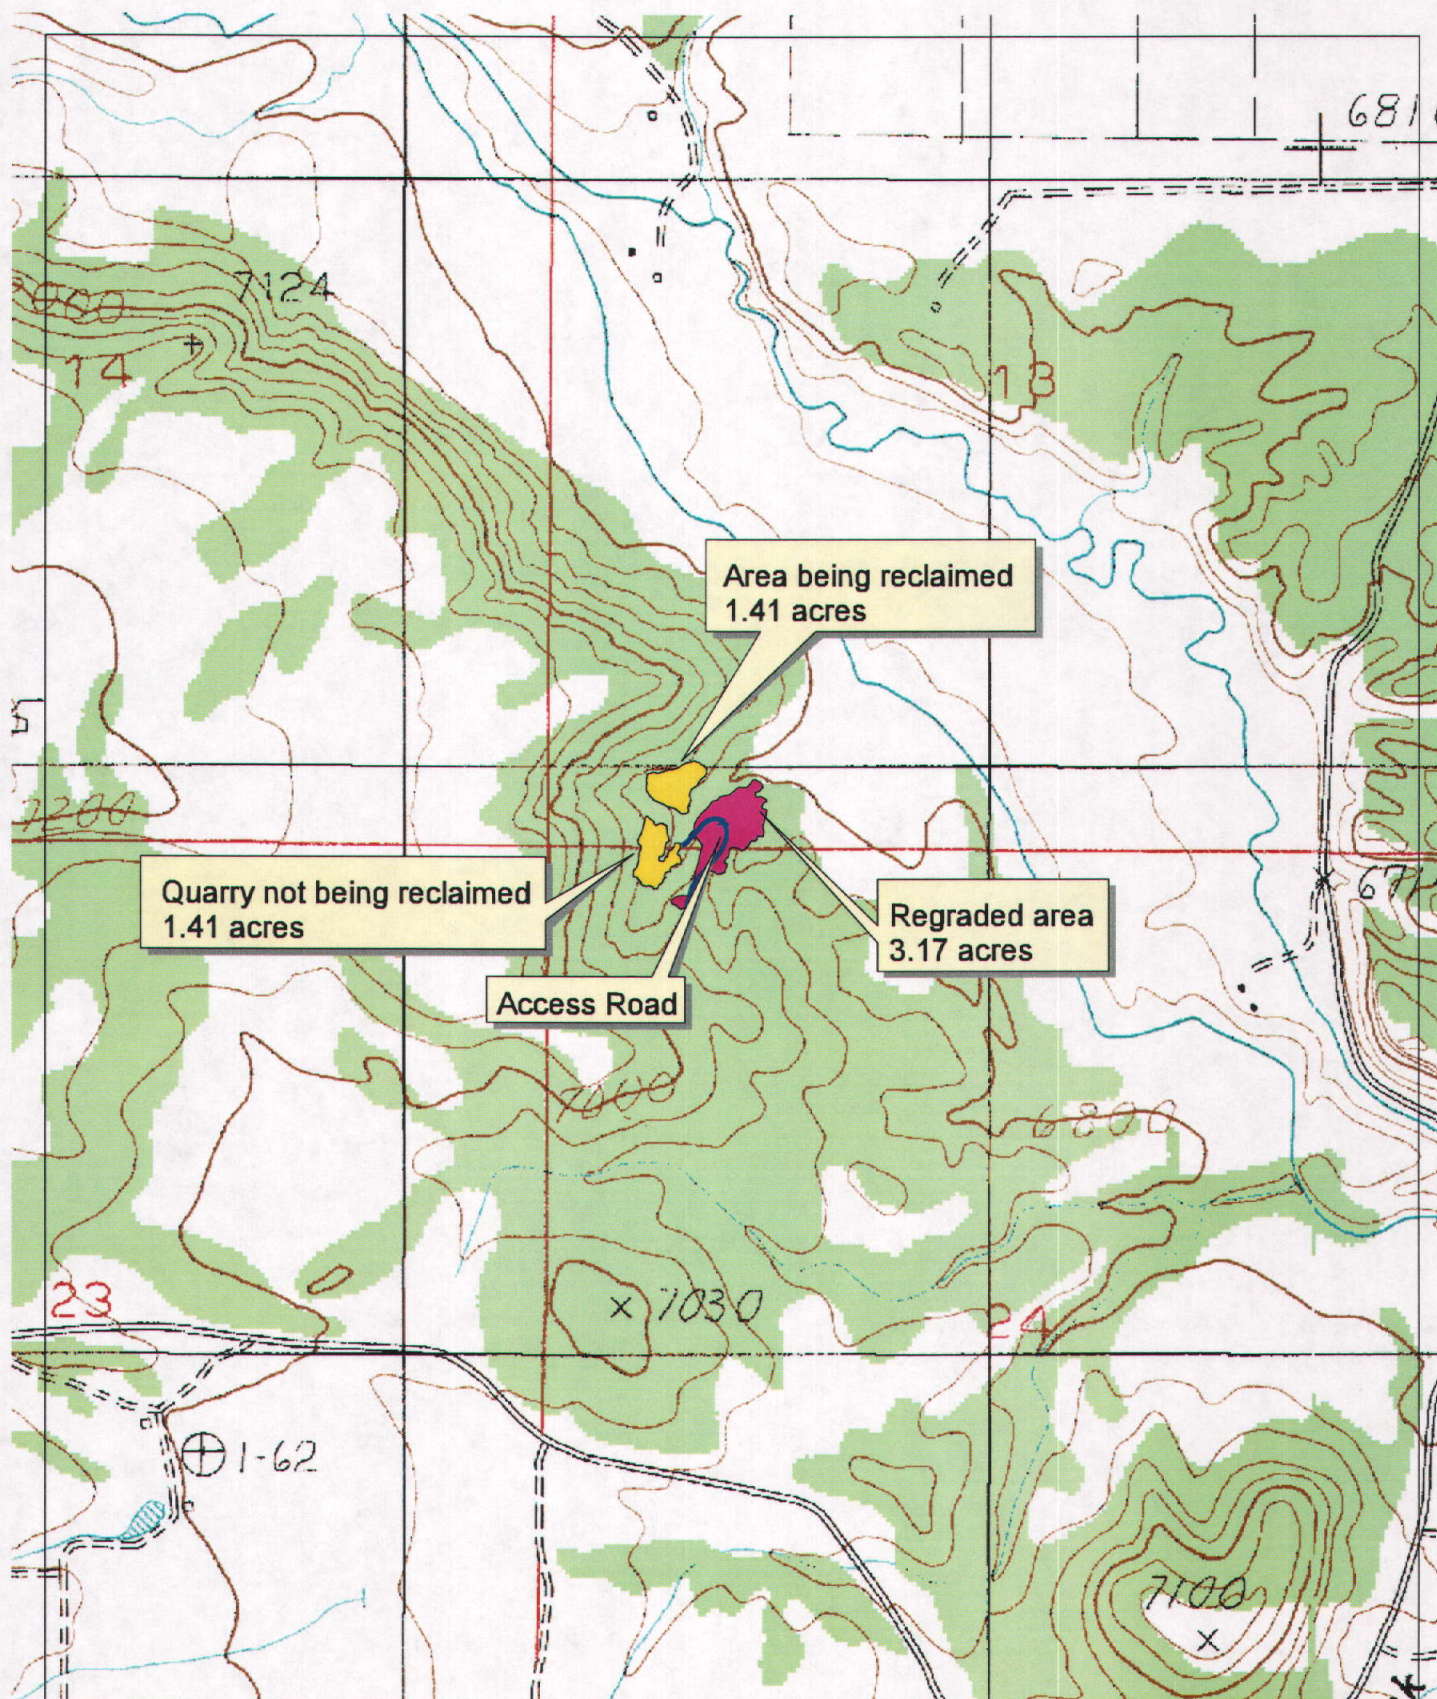
The east portion of the buff quarry has been regraded but not yet seeded. This area is shown in purple on the attached map. Mr. Pace said he is working to regrade the northwest portion of this quarry and that the operator will continue to mine the southwest portion.

The map attached to this report is a compilation of GPS data gathered during this inspection and during the March 2004 inspection. The purple area has been regraded, and this information was gathered in March. The yellow areas and the road were mapped during the current inspection and

show an area being reclaimed (northwest), an area to be used for future quarrying (southwest),
and the access road.
